NASA TN D-3571

# PROJECT FIRE PHOTOGRAPHIC SUMMARY AND RECORD OF REENTRY PHENOMENA AT HYPERBOLIC VELOCITIES

*by Charles W. McKee*  
*Langley Research Center*  
*Langley Station, Hampton, Va.*

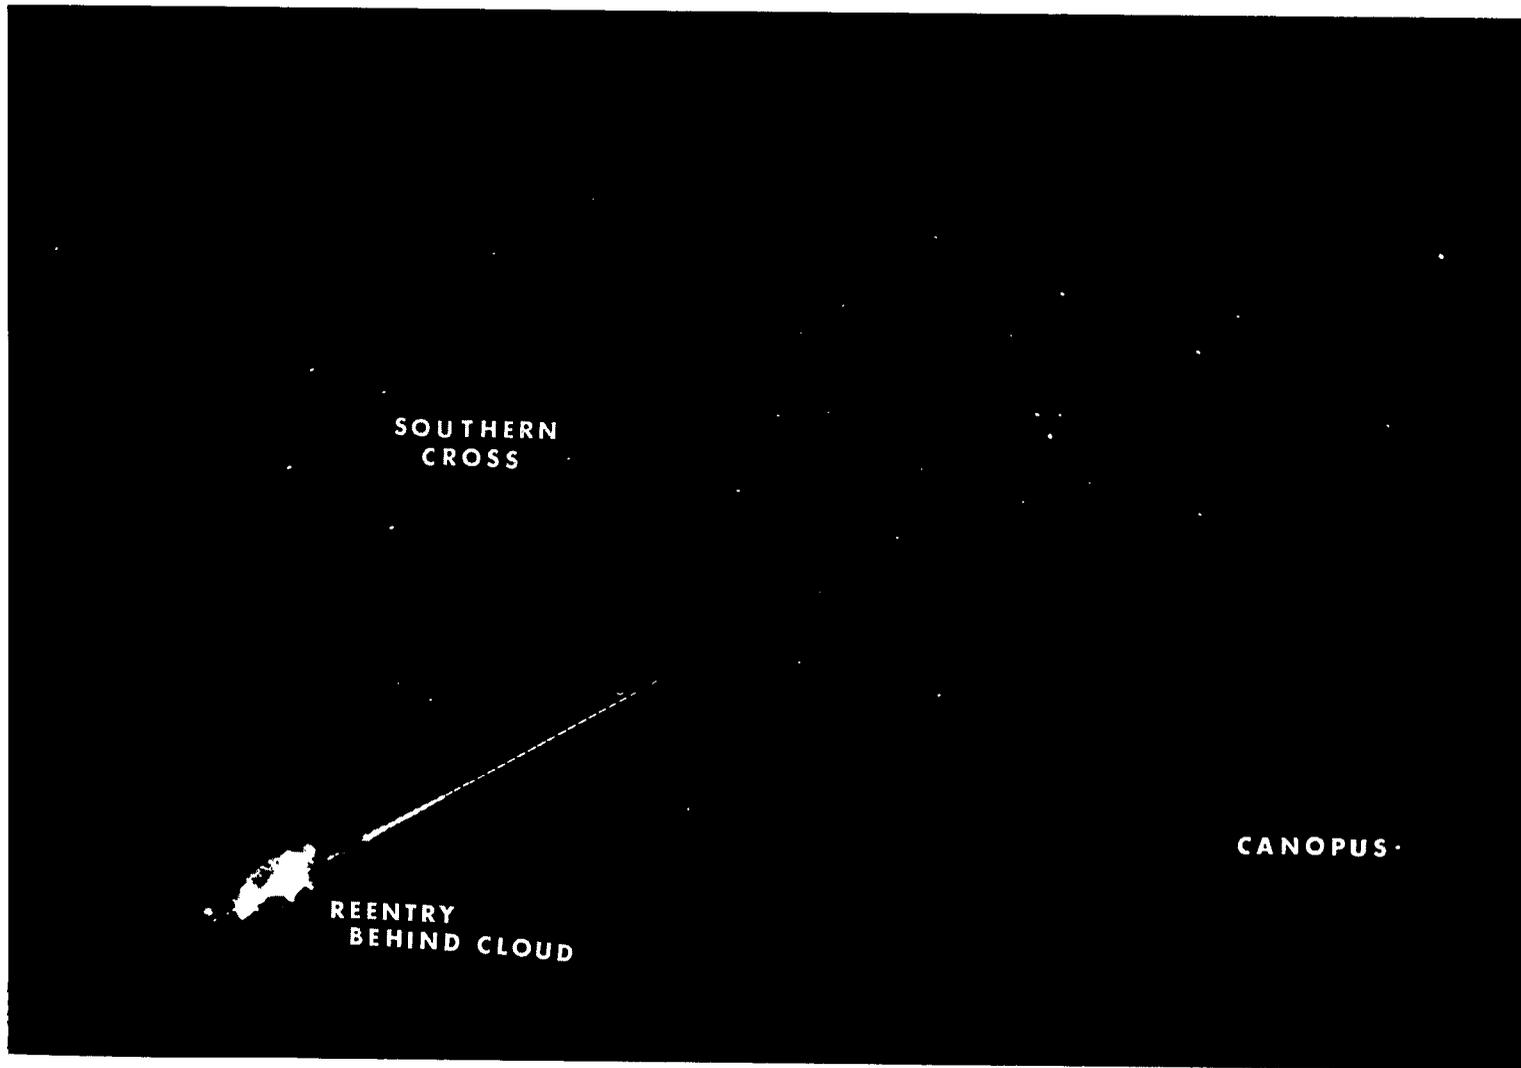
Figure 6.- Chopped photograph of Fire I reentry.

The photographic coverage obtained for the Fire I reentry was severely hampered by a cloudy sky condition and by the fact that the reentry portion of the flight presented a far more difficult tracking target than the operators of the photographic equipment had envisioned. (See fig. 6.) No previous tracking of an object traveling at the velocity planned for the Project Fire reentry package had been attempted by the Eastern Test Range, and the short data period of only 40 seconds permitted little opportunity to correct for an error in judgment or tracking rate. Also, the tracking of the reentry package was hindered by the fact that following closely behind the reentry package was a far brighter and more spectacular object, the spent Antares motor. The difficulty in acquiring and maintaining track of the reentry package was recognized prior to the flight, and a program of instructions and training for operators of optical and electronic tracking equipment was conducted. However, the lack of experience in tracking objects at the Fire reentry speed together with the poor visibility resulted in a poor photographic record of Fire I reentry. The value of the photographic record was emphasized during subsequent investigations conducted to determine the cause of some unexpected body motions experienced by the reentry package (ref. 1).

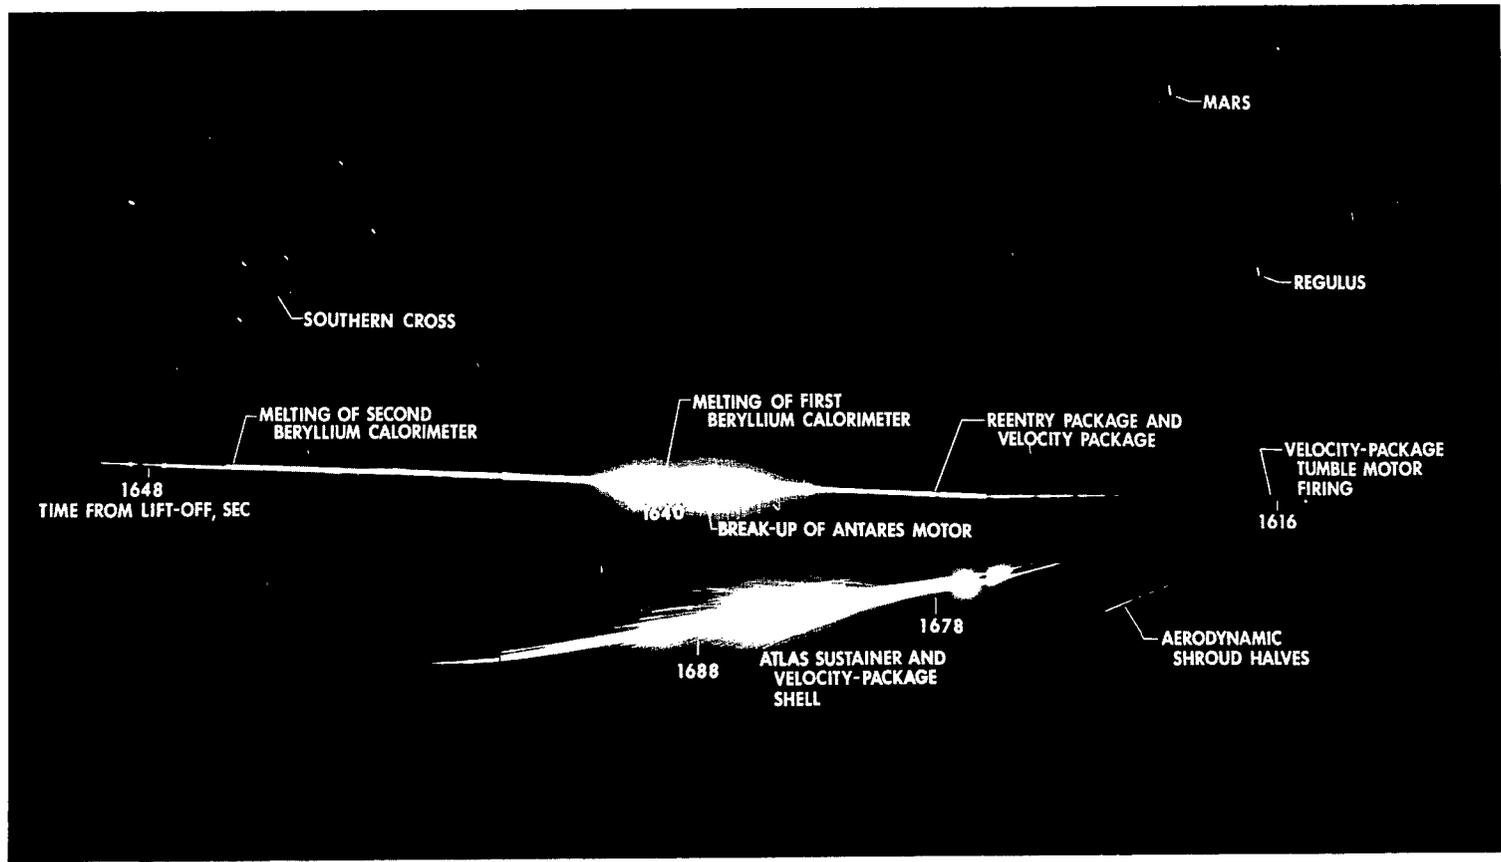
L-65-4713

Figure 7.- Montage of Fire II reentry viewed from Ascension Island on May 22, 1965.

Open-shutter camera coverage.- Figure 7 is a montage of the Fire II reentry as recorded by three open-shutter streak cameras located on Ascension Island. These K-37 cameras of 300-millimeter focal length used 038.01 high-speed panchromatic emulsion. Figure 8 is an open-shutter photograph of the entire reentry taken from an NASA airplane. This single photograph covers the time from first acquisition of the reentering spacecraft (right end of upper trace) at approximately 1633.324 seconds until final burnup of the last launch vehicle part (left end of lower trace) at approximately 1698.423 seconds. This photograph of 65 seconds duration was made with a minimum of photographic distortion, as can be appreciated by comparing it with a montage made from the ground-based still cameras. The airplane wing (see lower right corner of figure)

was illuminated by available light from the reentry phenomena. The upper trace is the reentry package and the spent Antares motor case following the same trajectory. The small trace located slightly above the large lower trace is the velocity-package shell which was ejected after spinup and before the Antares ignition. The large lower trace is the launch vehicle, and the point of residual fuel explosion and subsequent breakup of the vehicle can be seen.

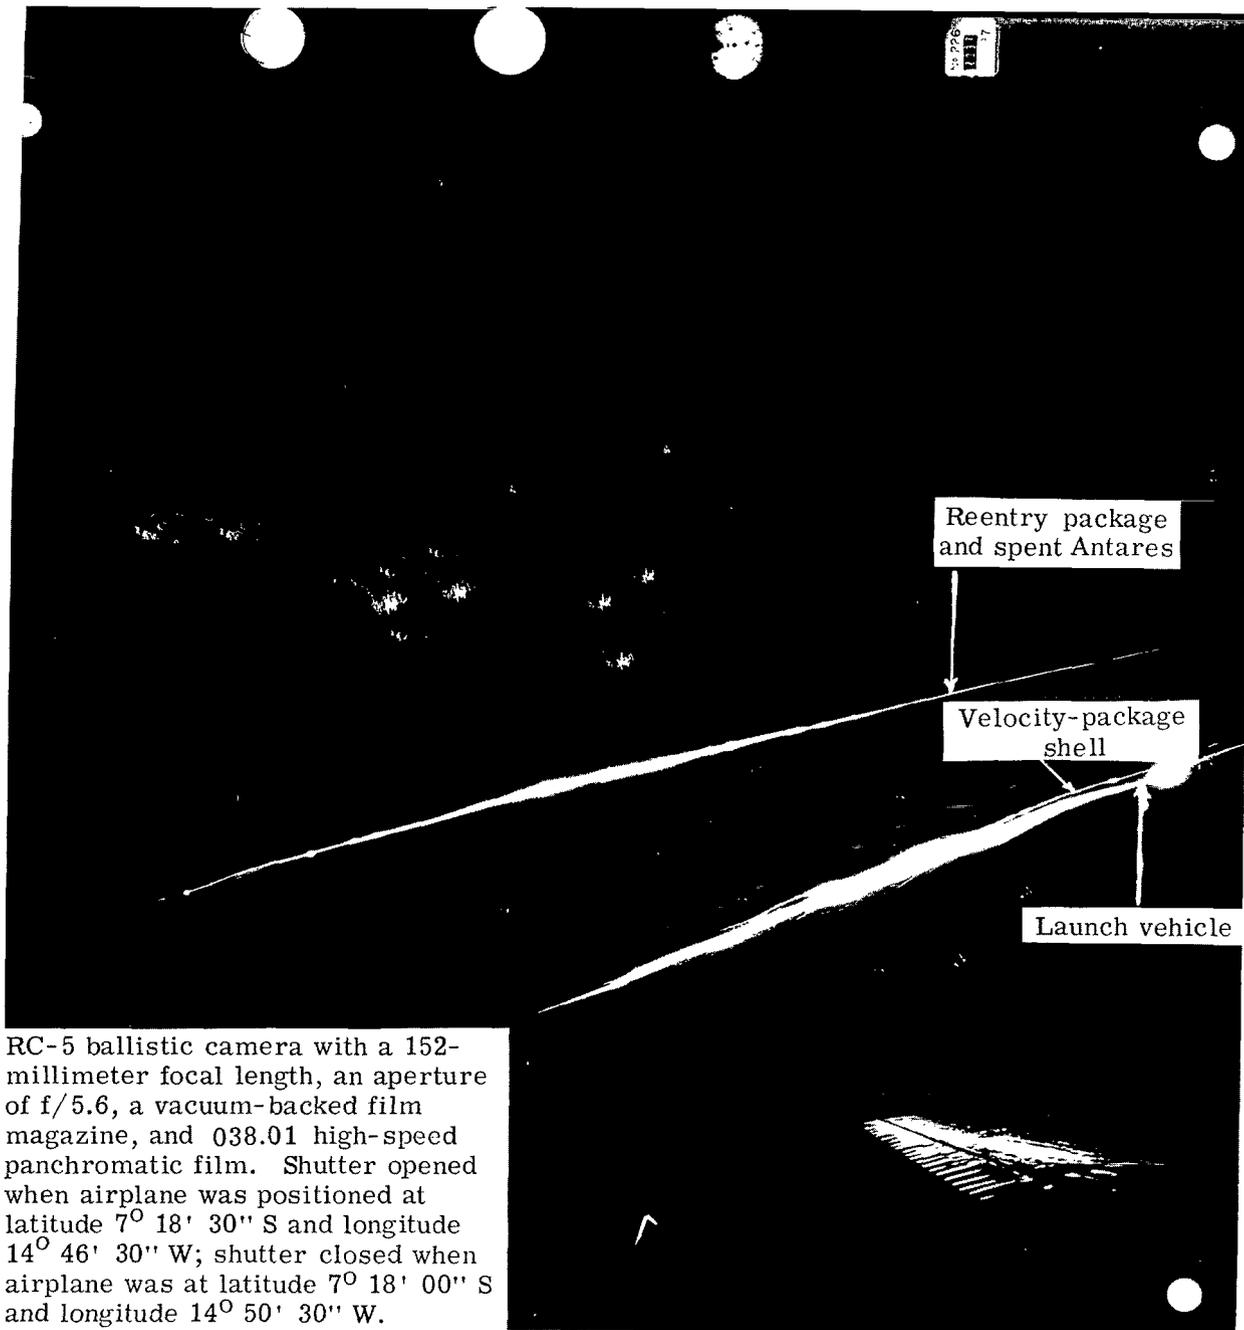
L-66-4446

RC-5 ballistic camera with a 152-millimeter focal length, an aperture of f/5.6, a vacuum-backed film magazine, and 038.01 high-speed panchromatic film. Shutter opened when airplane was positioned at latitude  $7^{\circ} 18' 30''$  S and longitude  $14^{\circ} 46' 30''$  W; shutter closed when airplane was at latitude  $7^{\circ} 18' 00''$  S and longitude  $14^{\circ} 50' 30''$  W.

Figure 8.- Open-shutter photograph of Fire II reentry taken from NASA airplane No. 238 at an altitude of 3200 meters and a heading of  $292^{\circ}$  when the shutter opened and  $277^{\circ}$  when the shutter closed.

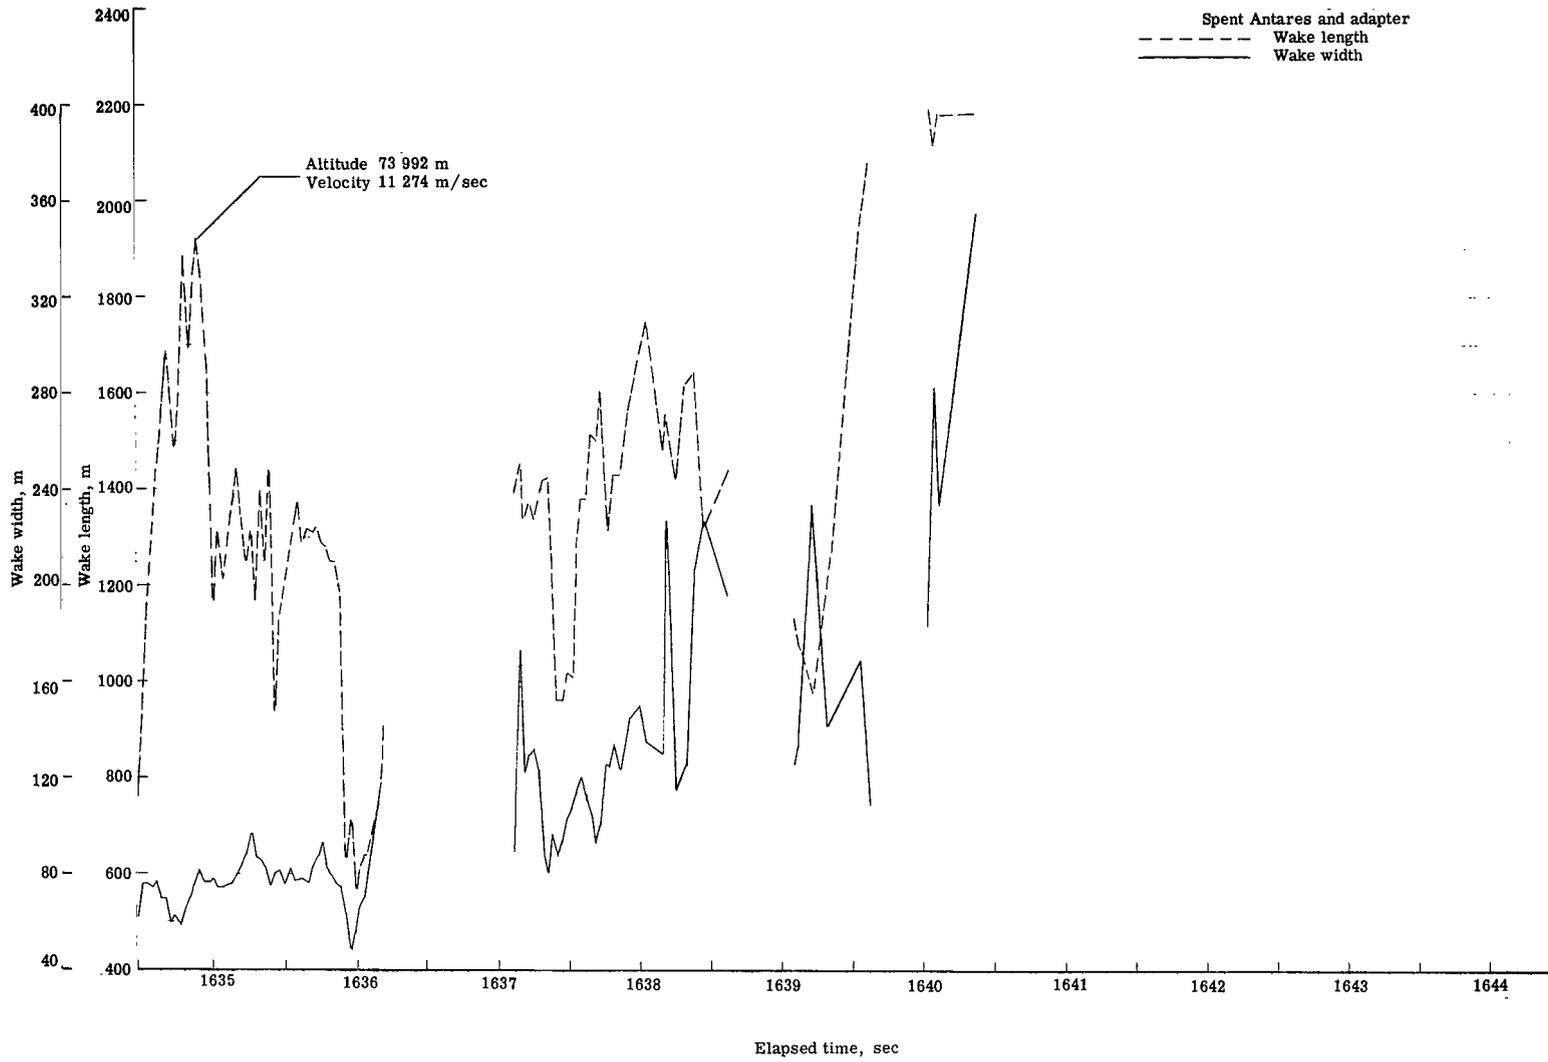
Figure 10.- Visible wake dimensions.

(a) Spent velocity package.

period were made from 70-millimeter black and white film. Figure 10 presents results of these studies for both the spent velocity package and the reentry package in relation to time. The possibility of optical halation effects or overexposure of the film was not considered when the wake measurements were made. Photographs taken with different camera systems and from different vantage points recorded wakes of comparable size. The tumbling motion of the spent Antares motor case and the adapter section caused the visible wake to fluctuate over wide ranges of length and width during the reentry. (See fig. 10(a).) The length of the visible wake fluctuated between 600 meters and 2100 meters as the spent velocity package penetrated the earth's atmosphere from an altitude of 75 kilometers to an altitude of 60 kilometers.

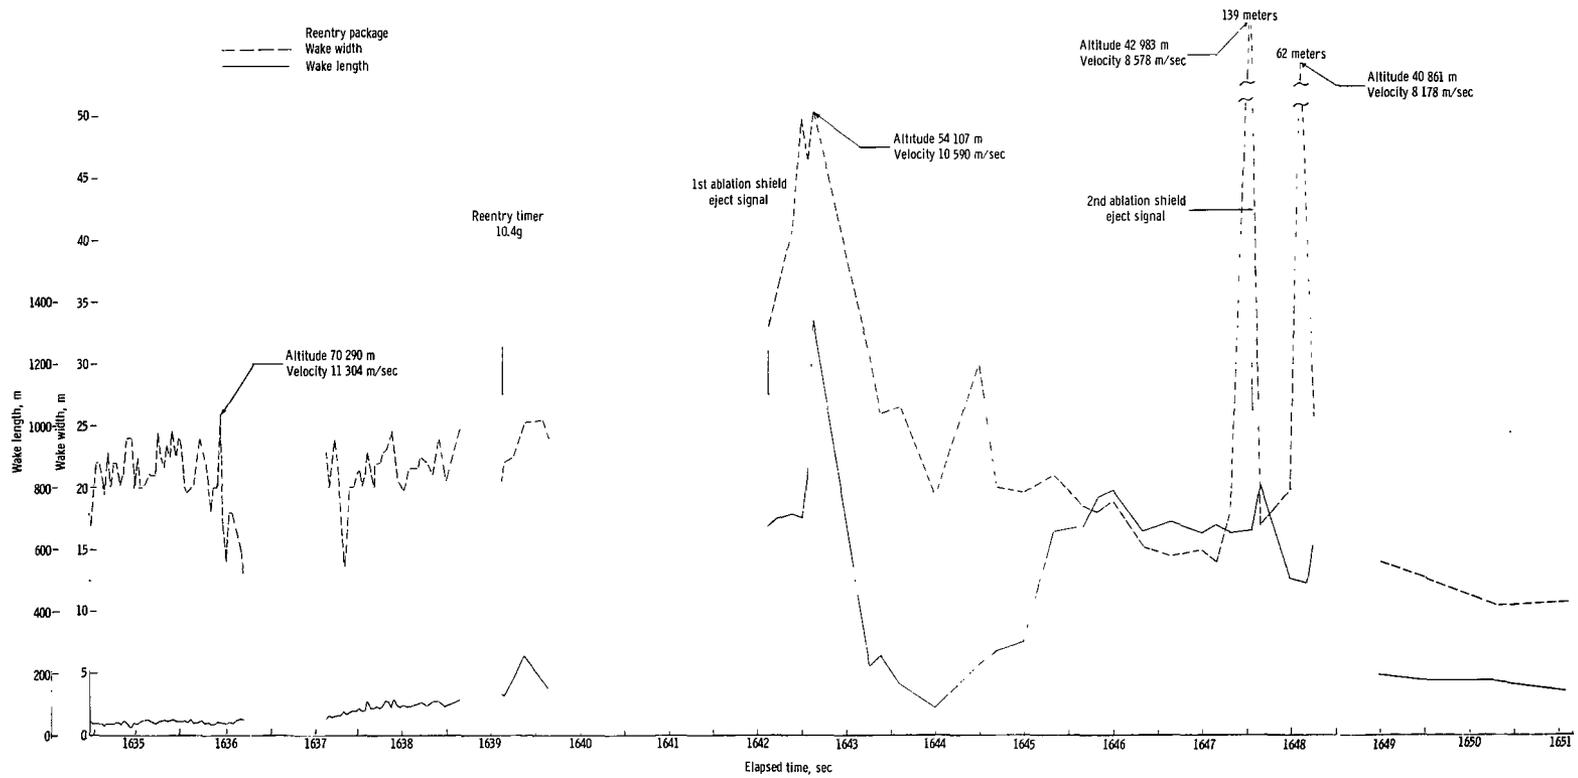
Figure 10.- Concluded.

(b) Reentry package.

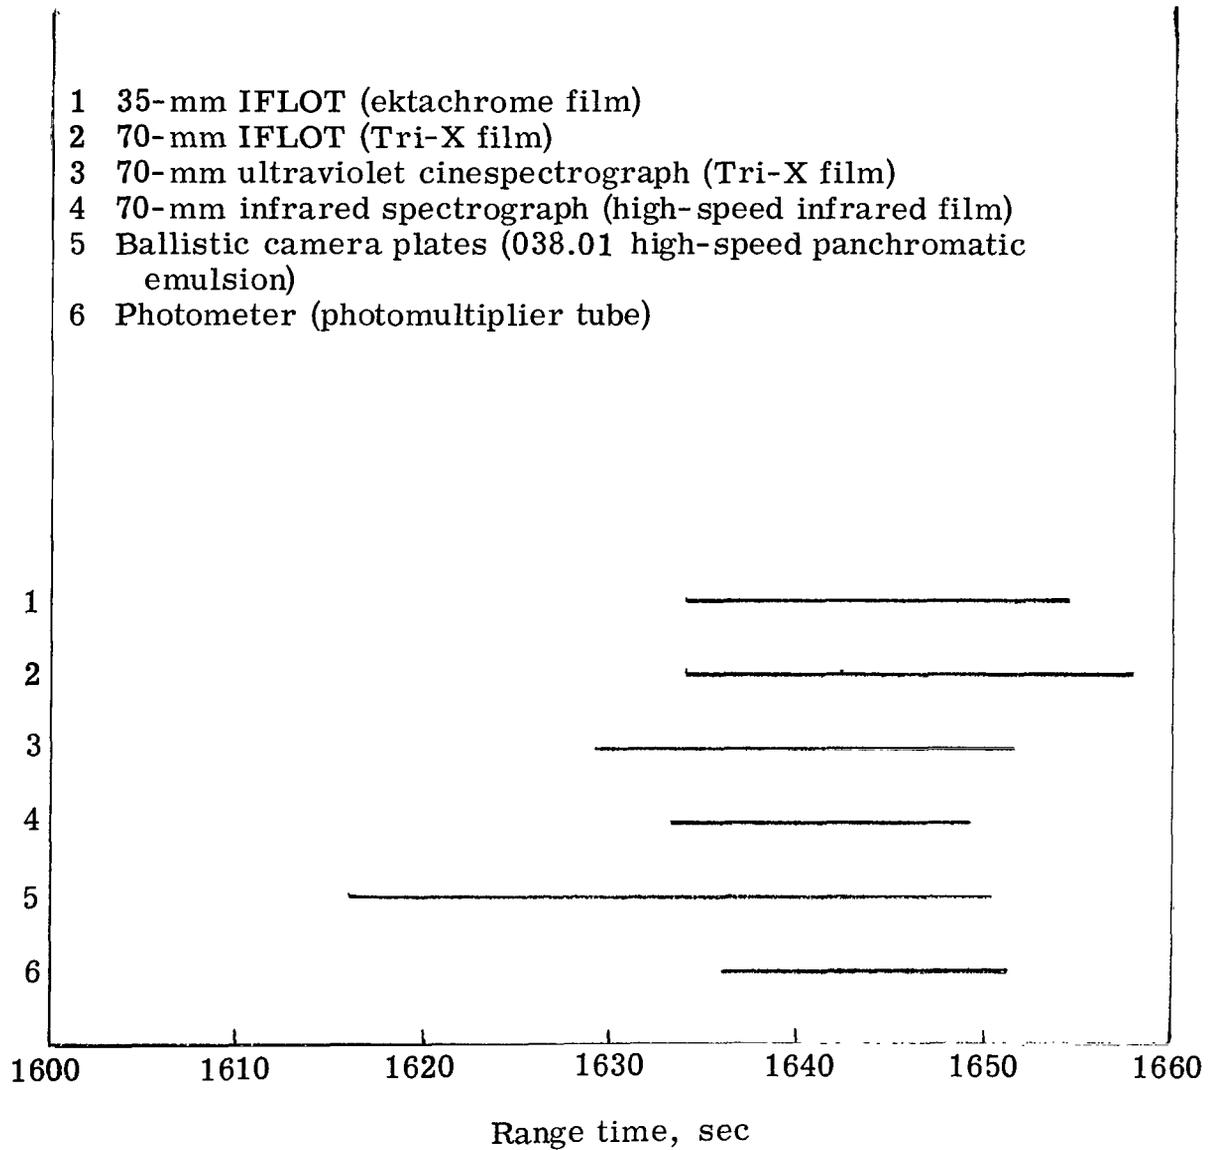
Figure 11.- Instrumentation and coverage times for signature data reduced by Eastern Test Range (ref. 3).

Optical signature data.- Additional data collected during the reentry in the form of spectrograms and photometric recordings were compiled and reduced by the Eastern Test Range Signature Processing. These reduced signature data have been analyzed primarily for diagnostic purposes. The reduced data are contained in reference 3. Caution should be exercised when using this reference. The time and trajectory differ from the time and trajectory used herein. In reference 3 the time is given to the nearest whole second and the trajectory information is derived from radar skin-track information for the spent Antares components rather than for the reentry package. Figure 11 lists the instrumentation and shows the times of coverage for signature data reduced by the Eastern Test Range. Samples of the spectrographs and samples of the type of reduction performed by the Eastern Test Range in support of Project Fire are presented in figures 12 and 13, respectively.

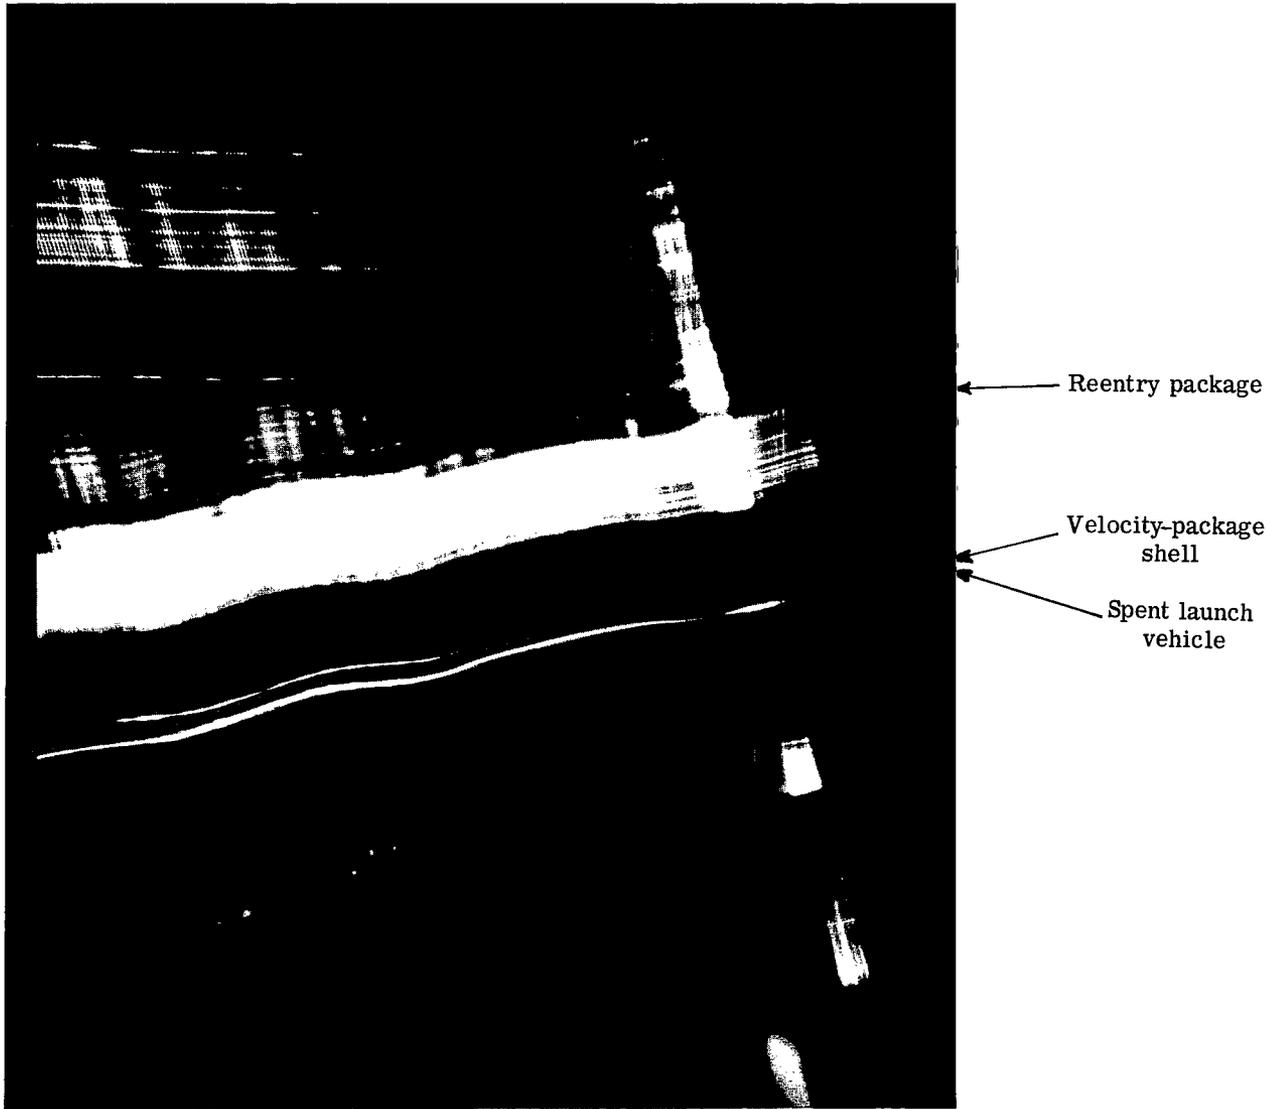
L-66-4447

(a) Spectrograph made from NASA airplane No. 238. K-37 camera; 150 lines/mm.

Figure 12.- Ballistic spectrographs.

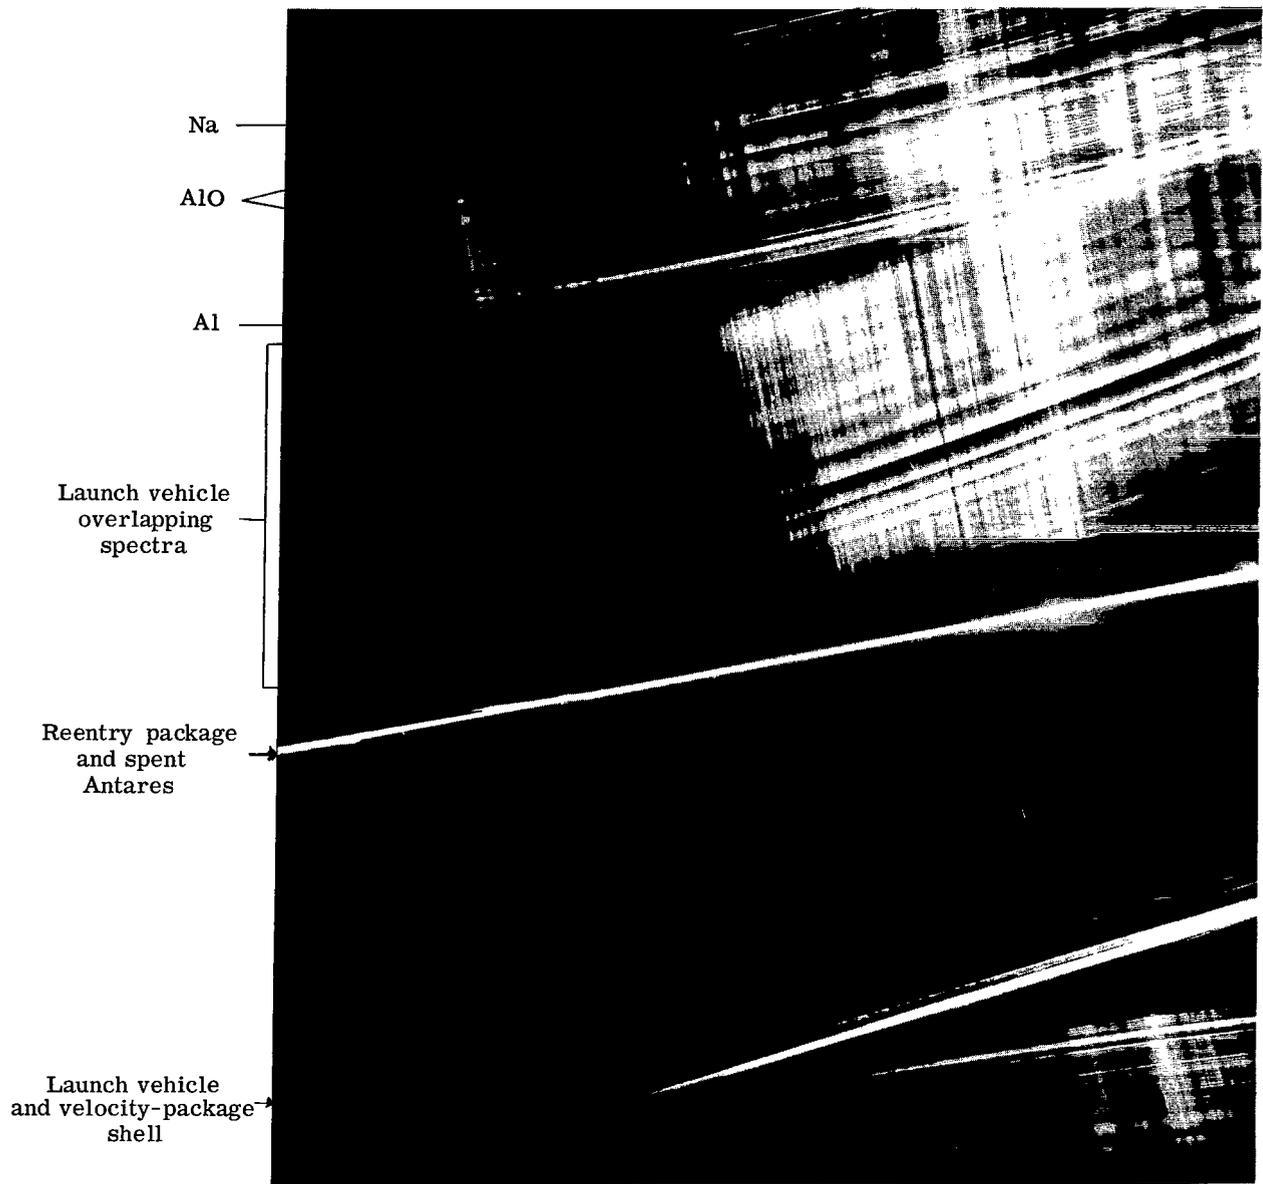
L-66-4448

(b) Spectrograph made from Ascension Island. K-37 camera; 600 lines/mm.

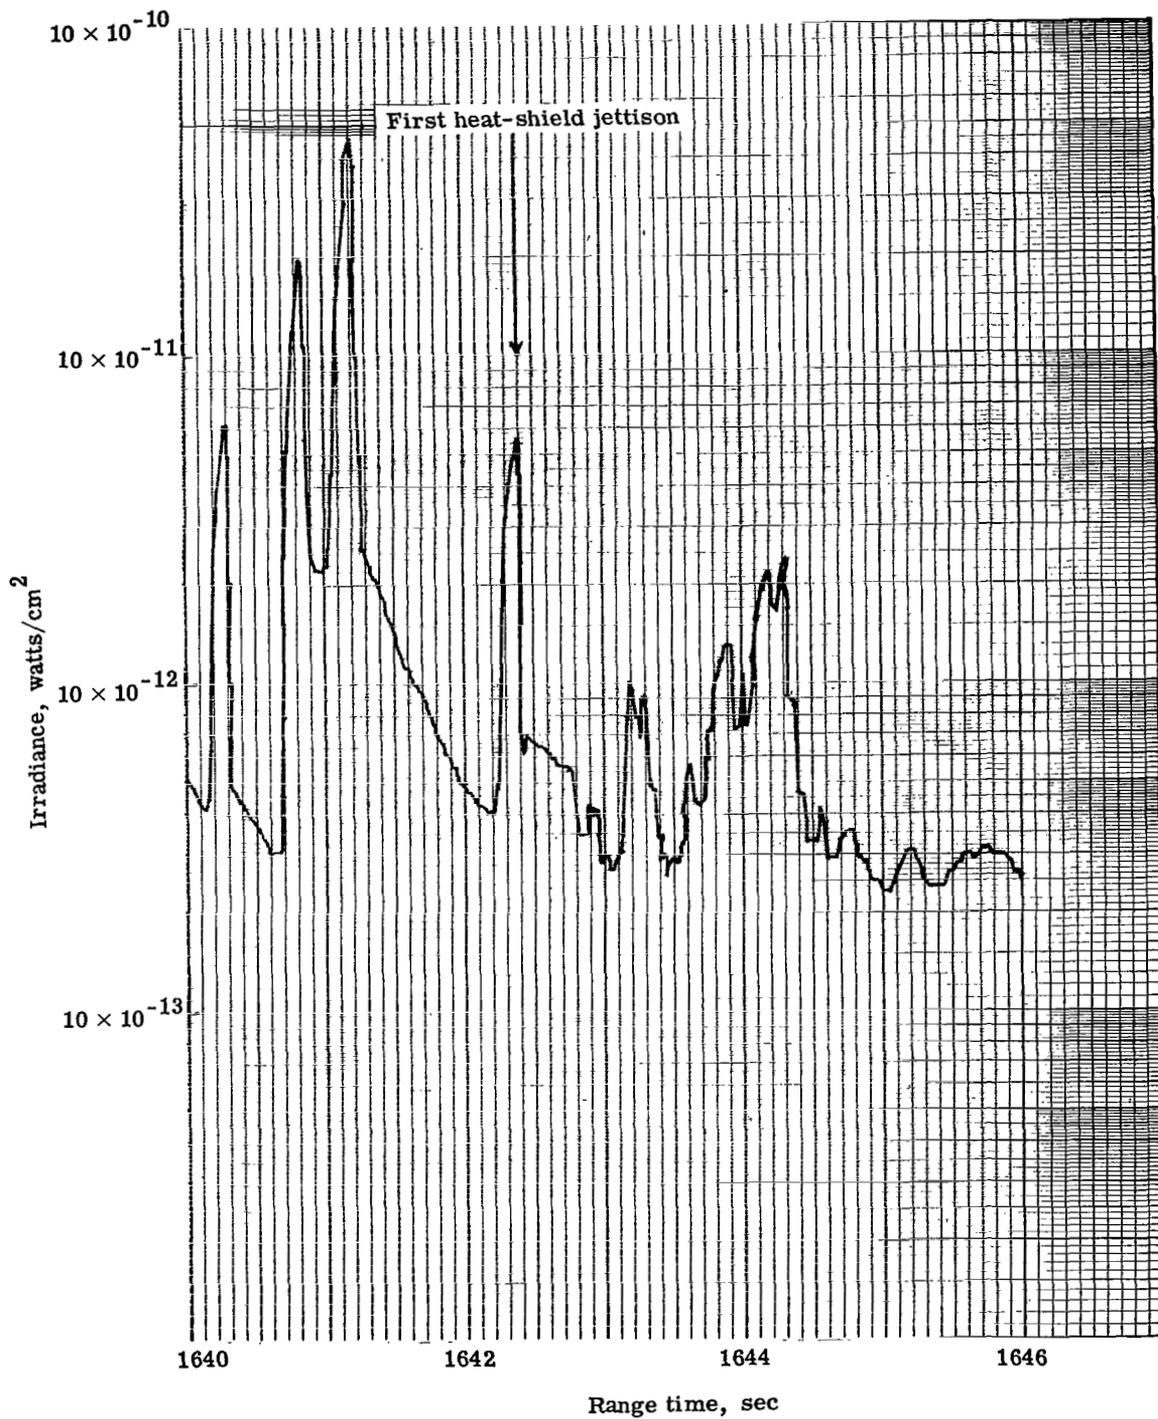
Figure 13.- Optical signature reduction.

(a) Irradiance as a function of time, measured at 0.42 micron.

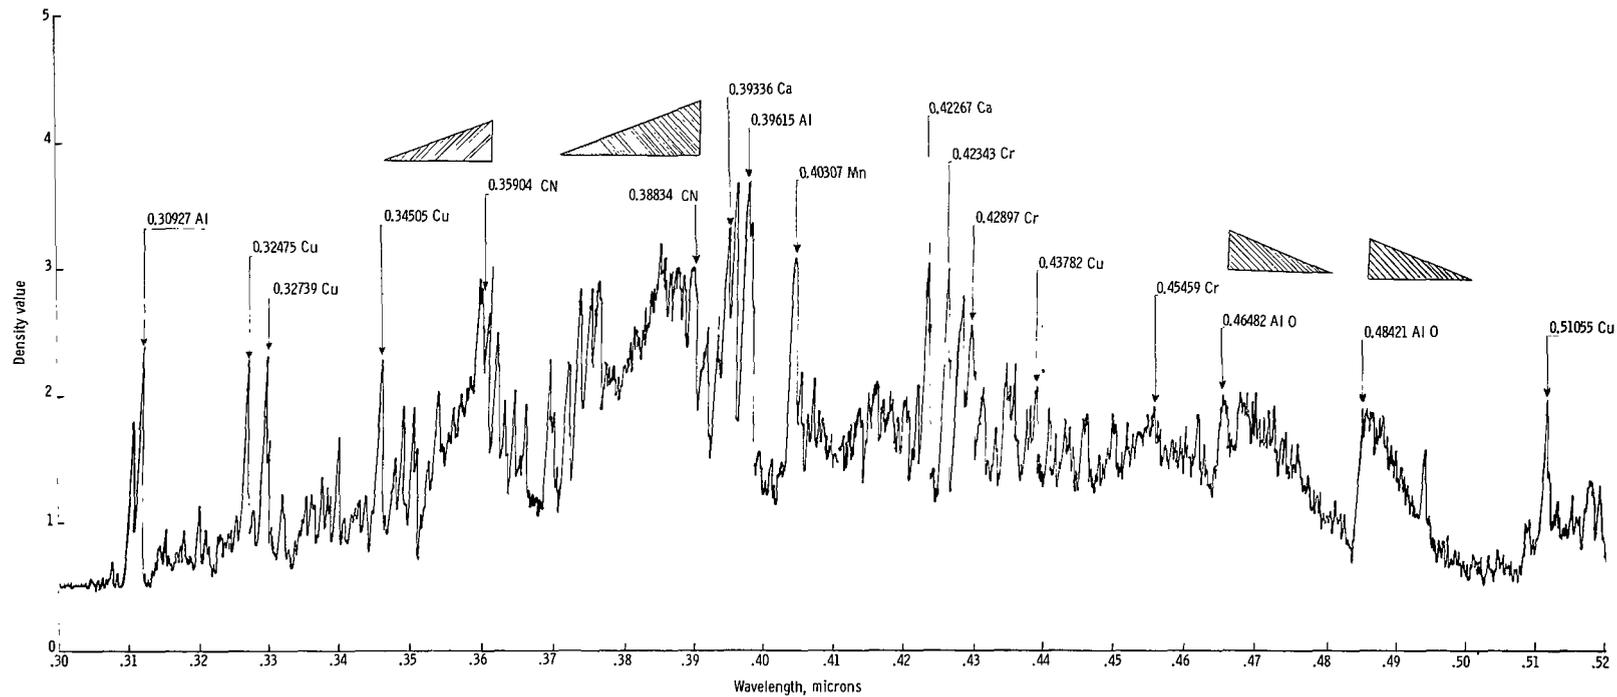
Figure 13.- Continued.

(b) Density as a function of wavelength (ultraviolet-visible).

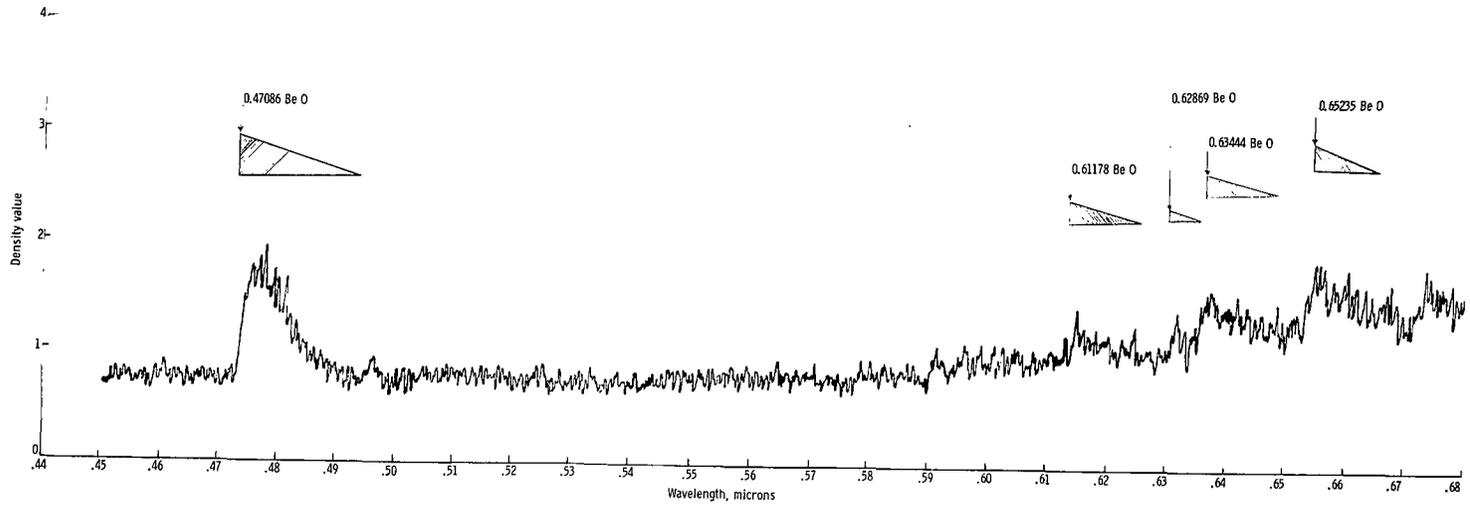
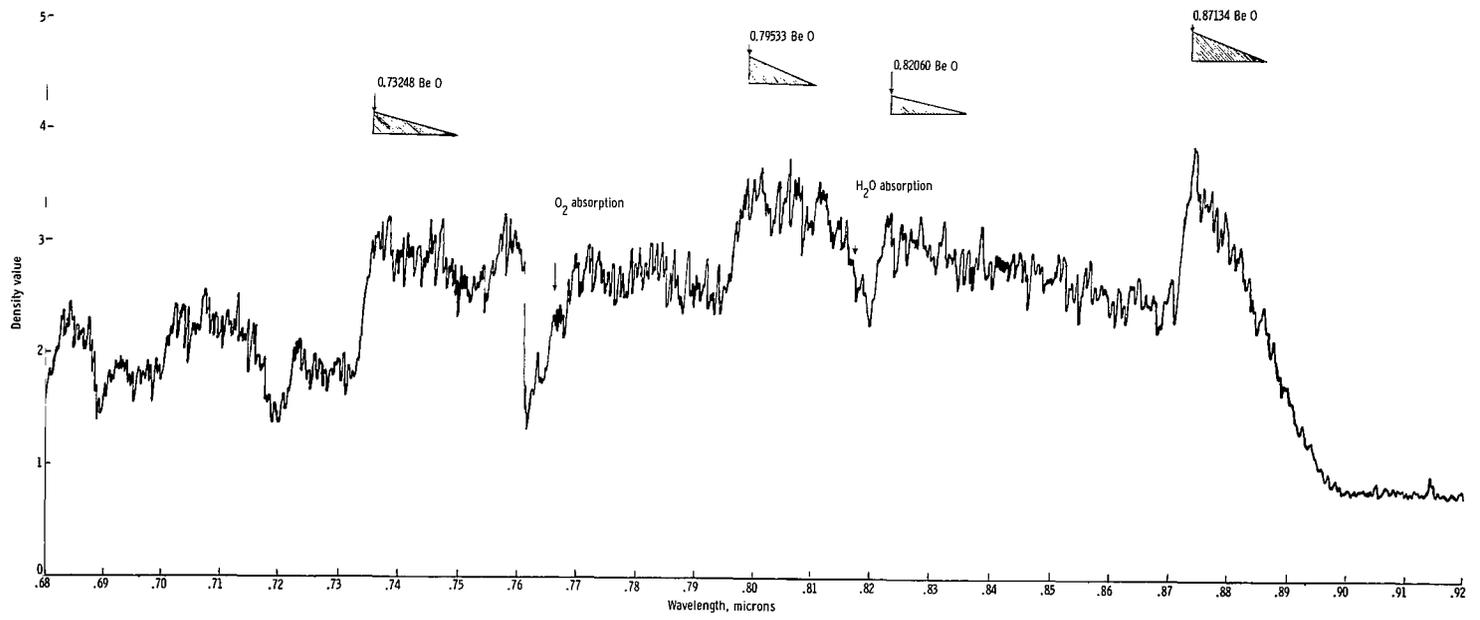
Figure 13.- Concluded.

(c) Density as a function of wavelength (infrared-visible).

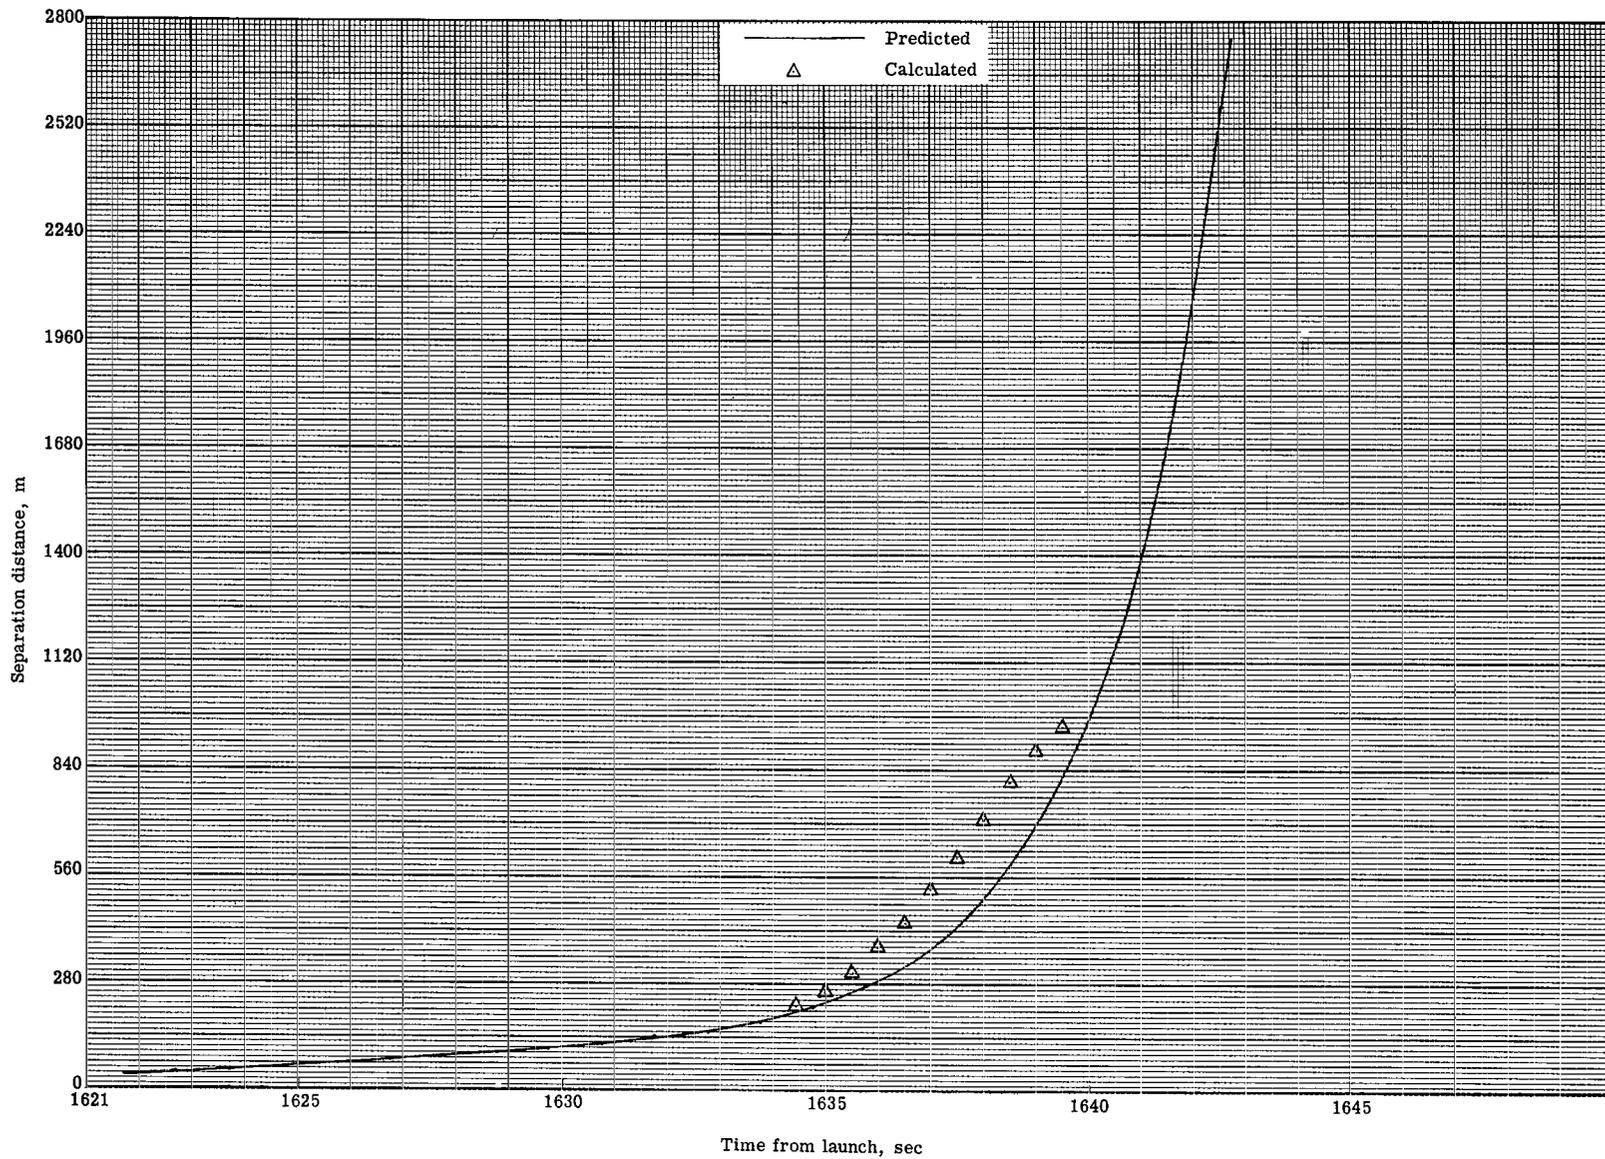
Figure 14.- Separation distance between Fire II reentry package and nearest component of the spent Antares and adapter.

Analysis of separation distance between reentry package and spent Antares.- For the Fire II operation a special effort was made to prevent a recurrence of the undesirable body motion experienced by the Fire I reentry package (ref. 1). In an effort to insure adequate separation between the reentry package and the spent Antares case, an additional small rocket motor was utilized together with a drag plate, as shown in figure 3. A six-degree-of-freedom analysis predicted a separation distance which would increase from 38 meters at 1621.74 seconds to 2743 meters at 1642.74 seconds. In order to determine the effectiveness of the separation system, engineering sequential photography was used to calculate the longitudinal separation distance achieved during the Fire II reentry. The results show that the separation distance was larger than had been predicted (see fig. 14).
